# **ASBESTOS ABATEMENT SERVICES**

**CLIENT: CITY OF ALLEGAN** DATE: SEPTEMBER 11, 2018 PROJECT NUMBER: 180614

> RE: **ASBESTOS SURVEY**

231 TROWBRIDGE STREET, ALLEGAN, MICHIGAN

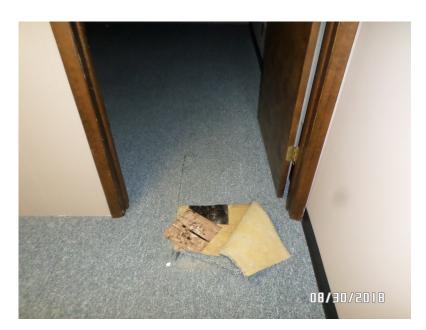
#12 - View of floor tile (HM-23 & HM-24) in basement of structure

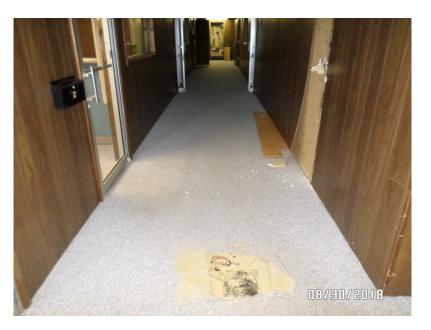
#13 - View of floor tile (HM-23 & HM-24) in Suite #16

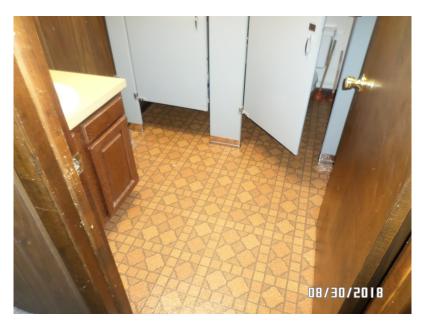
#17 - View of linoleum ACM (HM-21) in southern woman's room in basement

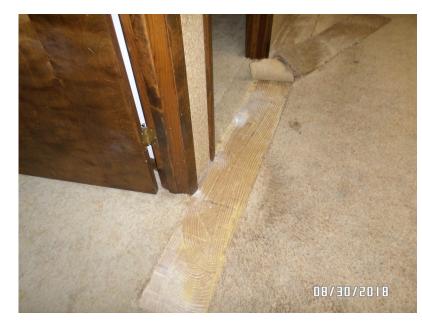
#18 - View of linoleum ACM (HM-21) in southern men's room in basement

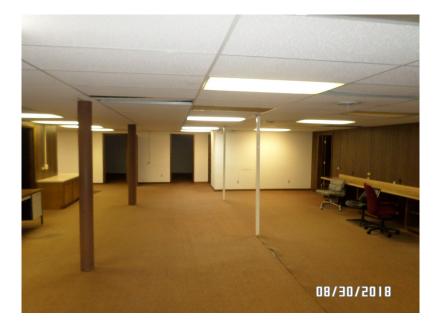
#19 - View of floor tile (HM-23 & HM-24) in Suite #17

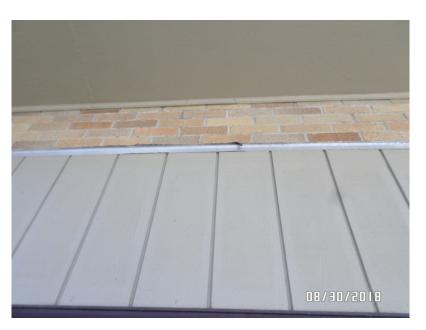
The white caulking (HM-27) identified between the wood window outline and brick façade on the north and west sides of the exterior of the structure contained 3% Chrysotile asbestos. The caulking is a Friable Regulated Asbestos-Containing Material (RACM) and will need to be properly abated by a licensed asbestos abatement contractor.

#25 - View of caulk (HM-27) between wood and brick on north and west building facade

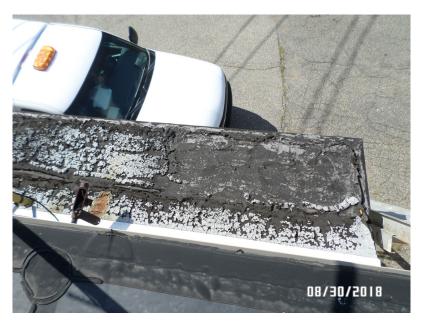
The black roofing material (HM-33) identified on the southern awning of the structure contained 3% Chrysotile asbestos. The roofing material is a Category I Non-Friable ACM.

#28 - View of top of south awning (HM-33)
